RESEARCH STUDY TO DEFINE
THE CRITICAL FAILURE MECHANISMS
IN NOTCHED COMPOSITES UNDER
COMPRESSION FATIGUE LOADING

B. W. ROSEN, A. P. NAGARKAR, R. B. PIPES AND R. WALSH

MSC TFR 1201/1801
MARCH, 1981

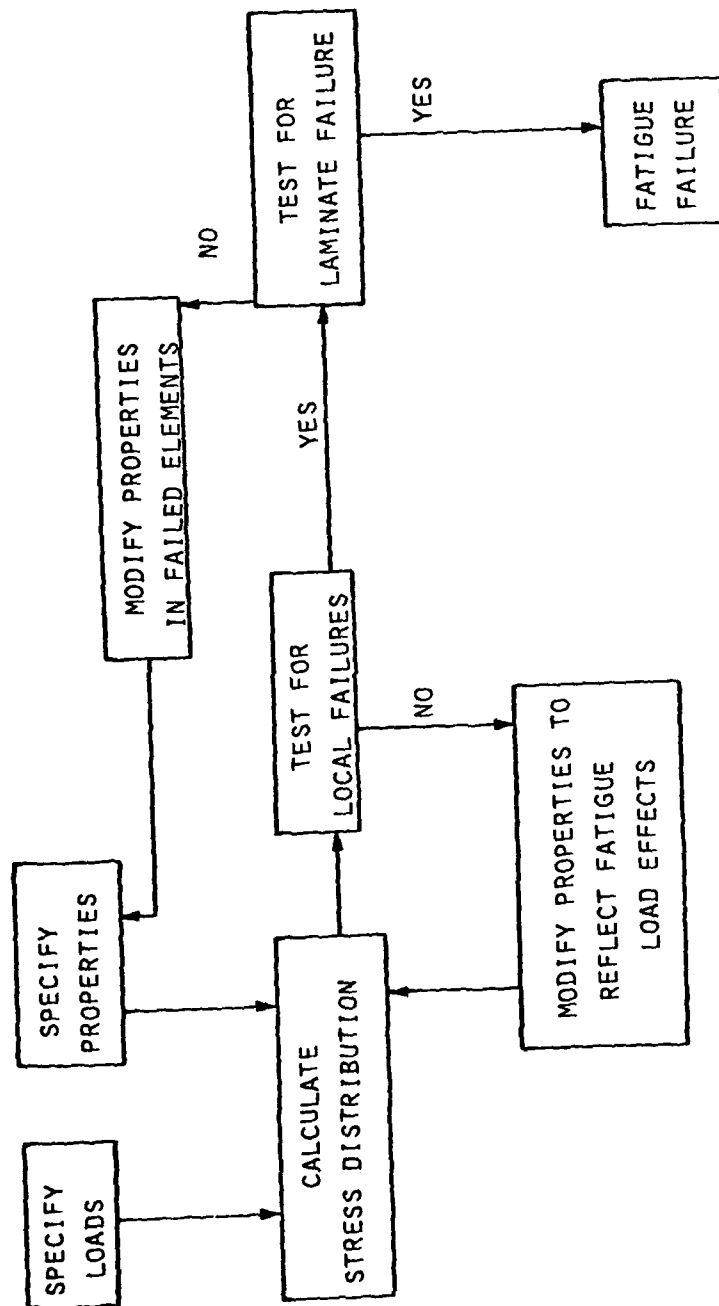
Figure 5. Methodology for Failure Analysis with Consideration of Load Cycling Effects

The failure analysis methodology is outlined in figure 5. In every load step, stresses are calculated with a finite element analysis for a unit load. For each element, assuming linear elastic behavior, failure load ratios are calculated from the stress distribution and all the failure criteria. The least ratio is determined and the element is predicted to fail in the appropriate failure mode. The least failure loads are compared to the actual applied load and the element or elements that have failed are identified. The possibility of gross laminate failure is then examined. If such a possibility does not exist, loss of strength and stiffness of failed elements is reflected in the next step by drastically reducing the stiffnesses and load-carrying capacity. The iterations can be carried out until the laminate fails.

Processing modifications in the failure analysis to consider fatigue effects are also included in the flow chart given in figure 5. It assumes the existence of unidirectional residual strength data as a function of both the number of fatigue cycles and the load level that are used as input (fig. 6). In this case, least failure loads are calculated and compared to the applied load to determine failed elements based on degraded residual strengths. Laminate residual strength can be determined using the residual unidirectional strengths.

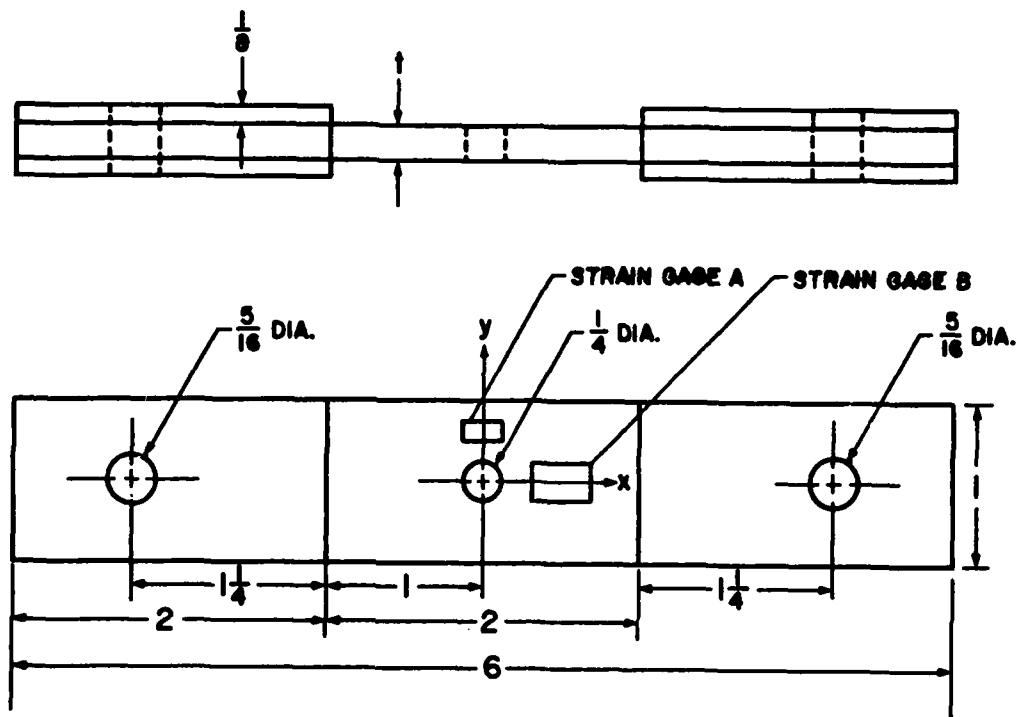
Figure 7. Notched Fatigue Specimen

The test specimen configuration, along with its dimensions, is shown in figure 7. The specimens were 1.0 inch wide with a 0.250 inch diameter circular hole located in the center of the unsupported span. The hole was drilled with a diamond coring bit to minimize any potential damage incurred during the process. The end tab length was 2.0 inches. To reduce the applied stress on the end tab adhesive, and thereby reduce the risk of debonding, it was desirable to increase the bonded area by increasing the end tab length. This was not possible, however, due to limitations imposed by the test fixture.

The gage length of the specimens tested in this program was 2.0 inches. In determining this dimension, the objective was to maximize the gage length without reaching a state of instability resulting in gross laminate buckling failures. The reason for maximizing the gage length was to minimize the grip effects. Specimen stability was verified experimentally under static loading, as well as with the Euler buckling calculation. One specimen of each type was strain gaged during static loading. The electrical resistance strain gages used to measure the strain in the test section and the far field strains were 0.0625 inch and 0.125 inch, respectively, and are also shown in figure 7.

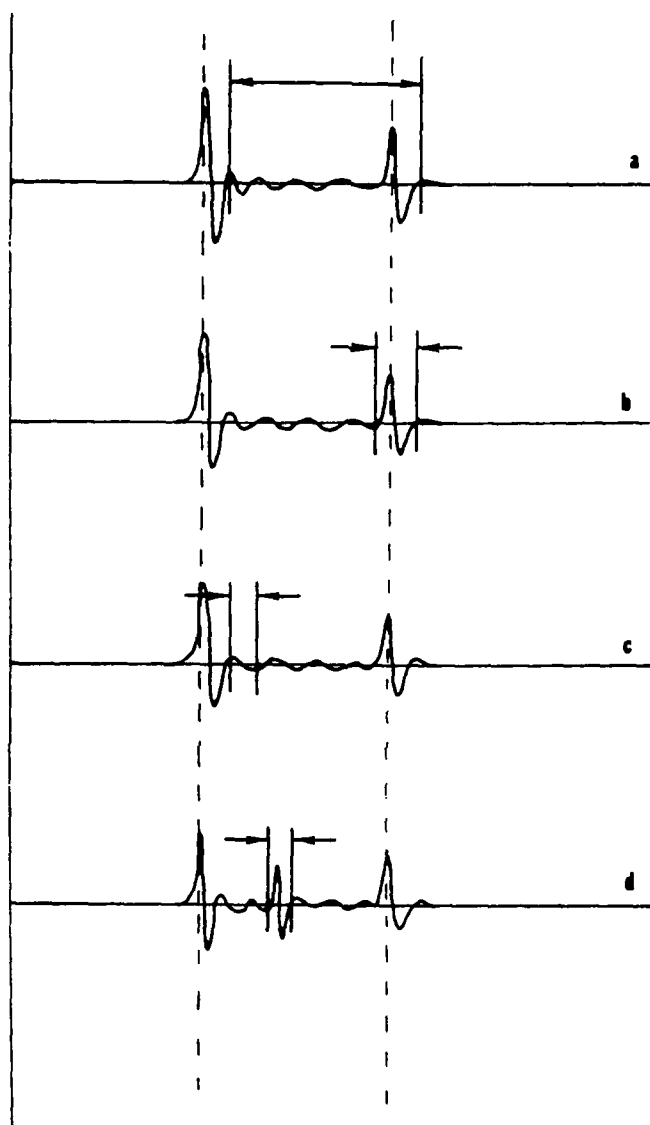
Figure 9. Gating Techniques

First, a C-scan is made of the specimen and then the transducer is located over the damaged area. The waveform on the oscilloscope will show the front surface ultrasonic echo, the back surface echo, and a delamination echo located between the two, the location of which is proportional to the location of the damaged region in the specimen thickness between the front and back surfaces. An example of this is shown in figure 9. By using the following equation, the lamina location can be derived:

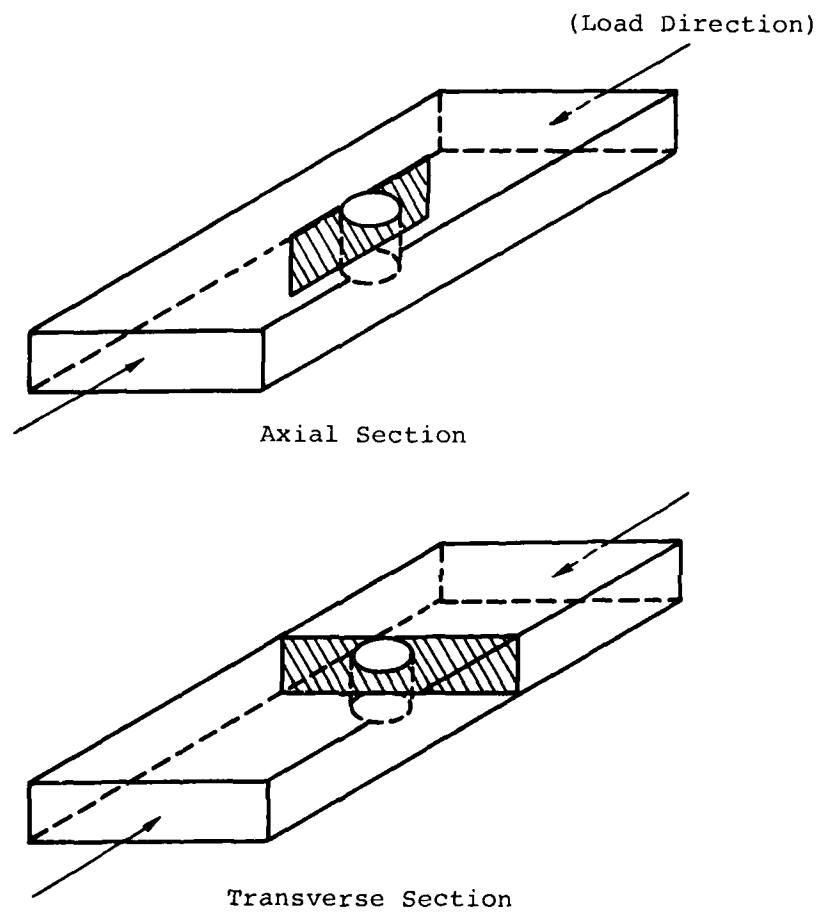
Figure 10. Micrograph Section Orientations

In an effort to examine in detail the fatigue induced damage, selected specimens were sectioned and photomicrographed. Specimens were sectioned both parallel and perpendicular to the longer axis tangent to the notch (fig. 10). These areas were chosen in order to include the major damage regions. The preparation of the section began by cutting a 0.1 inch slice from the desired location on the specimen with a rotary diamond saw. The section was then mounted in Buehler Epoxide Resin and polished. The polished surface is produced by a 0.3 micron abrasive proceeding through 11 successive polishing stages. All photomicrographs in this report were taken at a magnification of 50X.

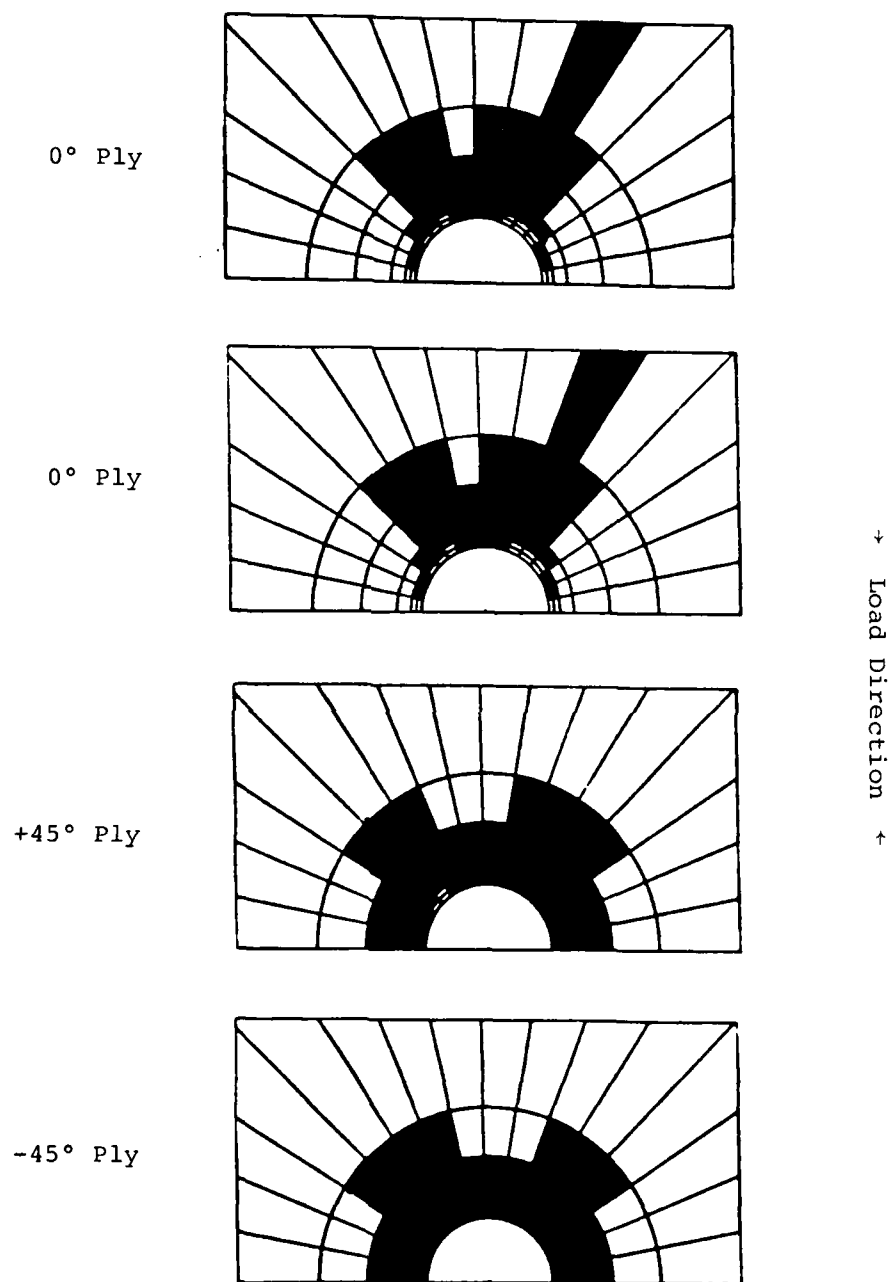
Figure 11. Intralaminar Damage in $[0_2/+45]_s$ - 5208
for a Load of 43.9 ksi

Extensive intraply damages, which are due to matrix failure, are predicted (figs. 11,14) in all the laminae. The failure criterion predicts failure due to the combined effects of transverse and shear stresses and therefore no distinction is made between transverse failure and shear disbonding. Matrix failure in the 0° plies is predicted to grow in the load direction, but restricted to the width of the notch. 45° ply damages, however, appear to have extended in two directions, along the fibers as well as in the direction perpendicular to them, initiating at notch edges at 45° to the load direction.

Predicted damage states for both resin systems (figs. 11,12, 14,15) are similar. Elastic moduli of the two systems are nearly equal, but there are differences in strengths in the virgin state as well as those assumed for degraded states. However, it appears that these differences are not enough to produce any significant change in predicted damage states. The C-scans (figs. 16, 17) and ply damages observed in the photomicrographs also do not

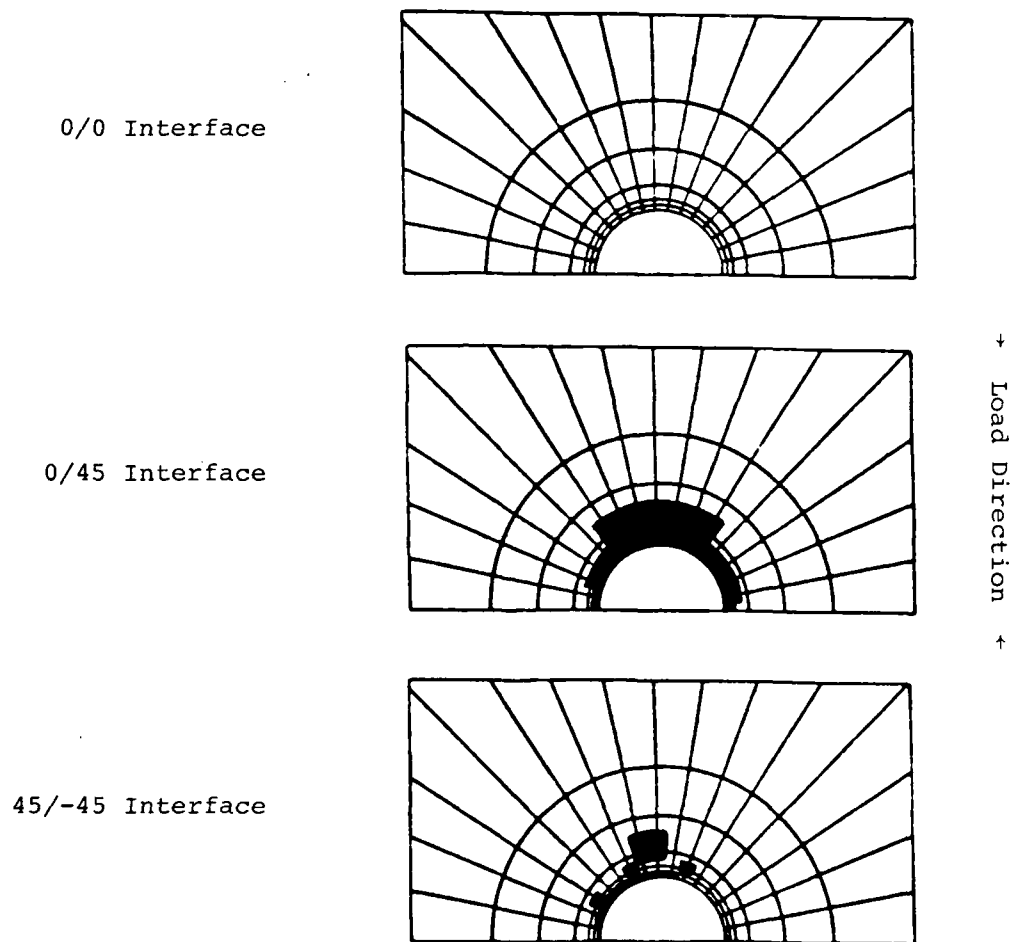
Figure 12. Interlaminar Damage in $[0_2/\pm 45]_s$ - 5208 for a Load of 43.8 ksi

The quasi-static analysis predicts delamination to initiate from the notch at the 0/+45 interface at an angle of $+60^\circ$ to the load direction. Growth of delamination at the 0/45 interface with increase of load obtained from a five step analysis is shown in figure 13. Although growth of delamination under quasi-static loading and fatigue could be different in nature, some similarities are noticeable in the initial stages of quasi-static loading and initiation of damage due to fatigue. Similarities are also seen in the predicted final damage states and those observed at the end of load cycling (see figs. 11-17). Delaminations at the end of quasi-static loading appear to have grown somewhat in the load direction, but primarily across the width of the notch (figs. 12,13,15). Some delaminations are also predicted at the +45 interface (figs. 12,15), which also have grown in the load direction (0°) across the width of the notch.

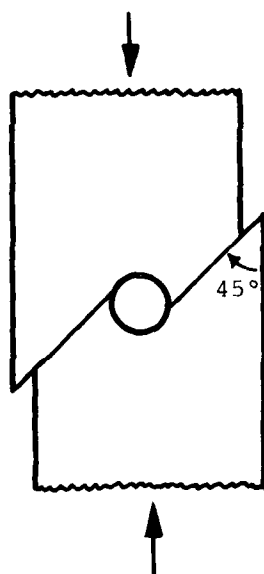
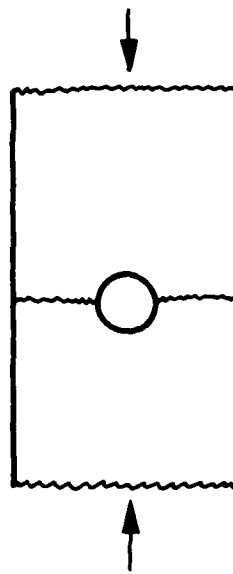
Figure 43. Notched Compression Failure Modes

Diagonal Shear

Net Compression
